**MULTIDIMENSÃO
E
TERRITÓRIOS DE RISCO**

**III Congresso Internacional
I Simpósio Ibero-Americano
VIII Encontro Nacional de Riscos**

THE ROLE OF PHYSICAL ENVIRONMENT IN THE GENESIS AND AMPLIFICATION OF FLOODS IN NADOR (NORTHEAST MOROCCO)

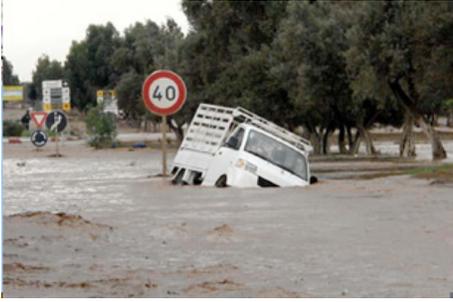
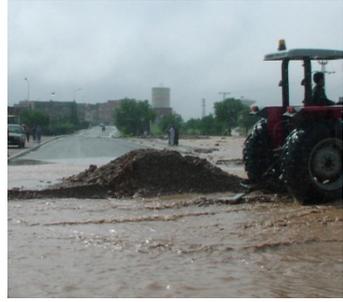
Floods that could have serious consequences are quite frequent in Northeast Morocco. They make roads dangerous and unusable (Photos 1, 2 and 3).

Photos 1-2-3. Examples of flood damage in Nador city (2008)

On 26th October 2008, Nador city and suburbs experienced a powerful unexpected brutal flood. According to official report, 4 people died and several buildings and roads were damaged, hundreds of victims relocated, drinking water supply cut, power network damaged, wells and irrigation channels, roads, bridges, all affected.

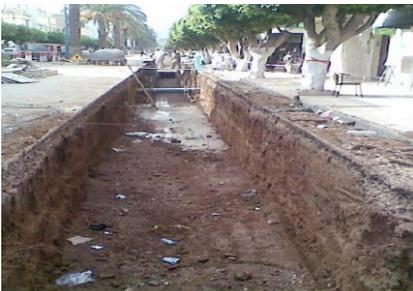
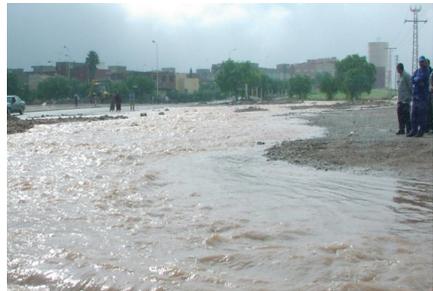
Photos 4-5: A rainwater channel (2009) to reduce flooding; flood in Nador (2008).

Several development works have been completed or are underway: overflow protection system re-establishment within streams, trapezoidal channel structures (bays, coating stairs, falls), bridges building and restoring, riverbed cleaning, landscaping slopes.
