ADVANCES IN FOREST FIRE RESEARCH 2018

Protecting lives and property: testing tanker crew protection systems

Rachel Bessell*¹; David Nichols¹; Justin Leonard²; Miguel G. Cruz³; Alen Slijepcevic¹

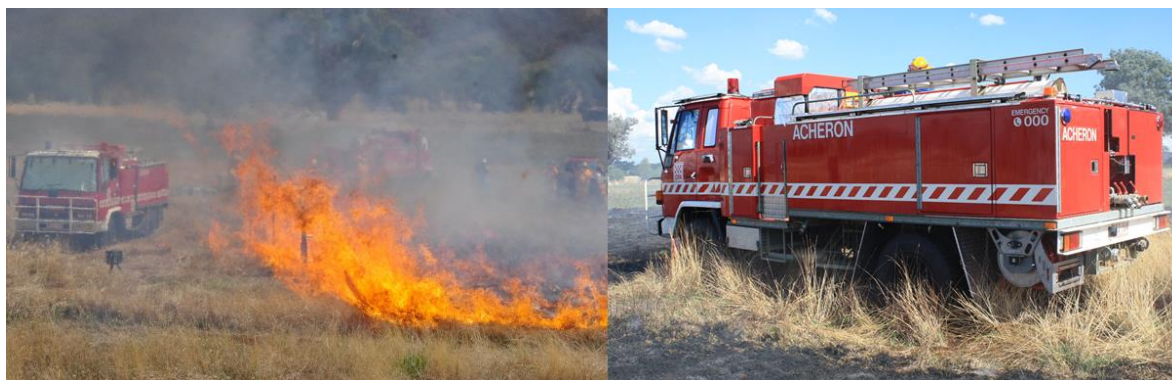
Overall there was no reported damage to the tanker, with the spray system providing adequate protection to the tanker as well as grass surrounding and beneath the tanker (Figure 1).

Figure 1 - CFA Medium tanker during and following the second experimental burn, Wangaratta, Victoria.

The medium tanker tests were replicated (two experiments) as the wind shifted and the headfire did not directly impact the tanker in the first experiment. During the second test, flame heights of 2.5m were recorded, with the flame front directly impacting the tanker. The water deluge spray system was activated from the start of the test, and it took the flames approximately 45 seconds to reach the tanker (Leonard et al, 2014). Maximum radiant heat, recorded on the passenger side door was 25kW/m². The inside air temperature remained unchanged throughout the test at 40°C. The peak temperature recorded on the outside passenger door was around 180°C noting that this temperature is within the water mist spray and hence does not reflect the true flame temperature (Leonard et al., 2014). Air toxics were only measured for the first medium tanker experiment, and recorded values were well below tenability and survivability thresholds.

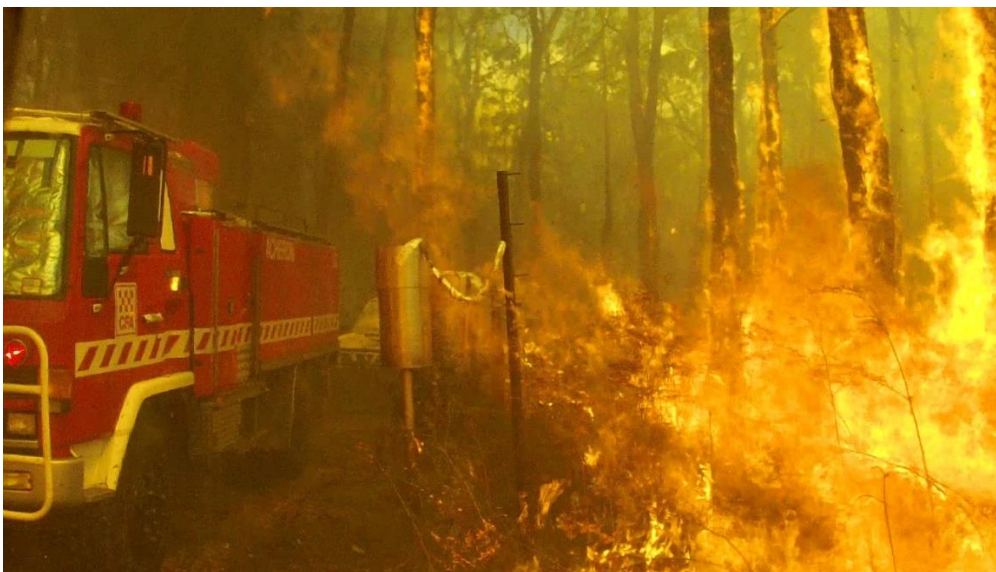
The fireline was ignited with two pairs of two igniters with hand-held drip torches, lighting an approximately 100m long ignition line. A high intensity flame front developed right after ignition, and a pseudo-steady state rate of spread was observed after 20m. Flame heights estimated to be 5-6m, with bark fuels allowing it to climb 10m up tree trunks. There were multiple spot fire ignitions occurring in front of the vehicles. It took 3.5 minutes from ignition for the fire to reach the tankers (Figure 2). Water sprays on the medium tanker, and CAFS on one of the ultra-light tankers were activated 2 minutes after ignition. The gel delivery system was still yet to be refined, as such the gel was pre-applied to the ultra-light tanker approximately 20 minutes before ignition. Considering the estimated fuel consumed, the average rate of spread was 31m/minute, which gives a fireline intensity of approximately 19,000kW/m² (Cruz et al., 2016).

Figure 2. Brucknell experimental burn impacting the CFA medium tanker, CAFS and Gel ultra-light tankers

The radiant heat peaked at 35kW/m^2 , four minutes after ignition. The outside temperature of the vehicle dropped once the spray system was turned on, and increased rapidly when the fire front reached the tanker (depicted in Figure 2), at 300°C . The inside air temperature remained unchanged at 33°C until after the fire front had passed, then it slowly increased over time as the water spray system was completed, but remained around 50°C . The crew compartment in the rear of the tanker started to rise following the fire front reaching 70°C for 90 seconds before declining in line with the internal temperatures. There was no visible damage to the tanker with the water deluge spray system also protecting the remnant fuels surrounding and beneath the tanker (Figure 3). No tenability or survivability criteria were exceeded in the medium tanker cabin except for smoke ingress (Leonard et al., 2016).

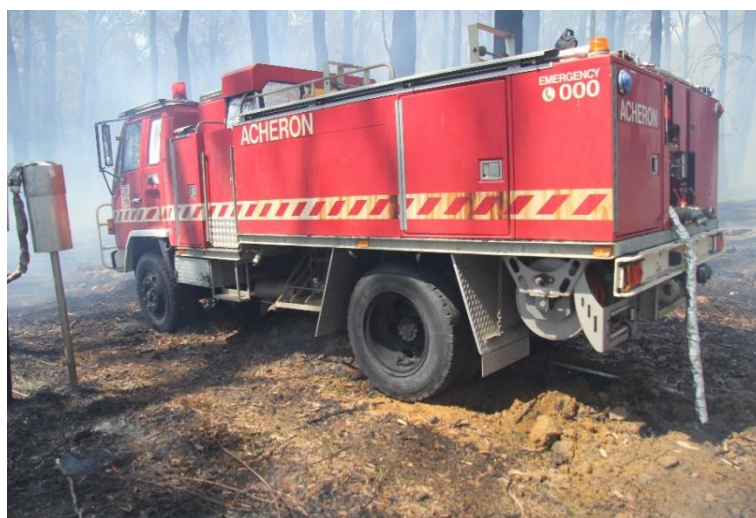
Figure 3. CFA Medium tanker after Brucknell experimental burn

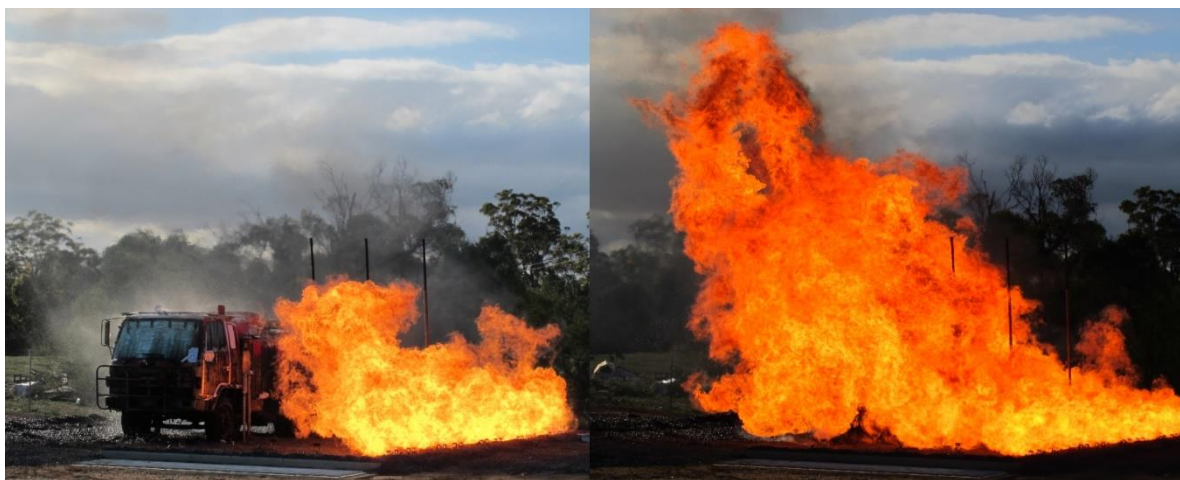
For the medium tanker at 10,000kW/m² and 15,000kW/m² resulted in no survivability criteria being exceeded for the truck cabin with the exception of respirable particles. For the 25,000kW/m² test, the tanker was compromised by the earlier experiments (Figure 4) and exhibited more failures to tenability and survivability, though a less extensive range of air toxics were measured.

Figure 4. CFA Medium tanker on the flame front simulator during the 25,000kW/m² Mogo, NSW, experiment

Outside temperatures at 1m peaked at around 800°C for all three experiments. The inside air temperature peaked at around 50°C for the 10,000kW/m² and 15,000kW/m² experiments and 70°C at the cabin ceiling (50°C at seat height) in the 25,000kW/m² experiment.

The test confirmed that the medium tanker crew protection systems are robust enough at even the highest level of 25,000kW/m² fireline intensity with cabin air temperatures remaining at survivable levels. At 25,000kW/m² the cabin was compromised before the experiment began due to damage in earlier tests; and the truck exhibited more significant failures of air toxicity tenability and survivability. At the lower intensities (10,000kW/m² and 15,000kW/m²) no survivability criteria was exceeded with the exception of respirable particles.
